## **Audi S8/A8 D4 platform (Mine = 2016 S8)**

### ***Audi Traffic Sign Recognition (Speed Limit Indicator) Retrofit Guide***

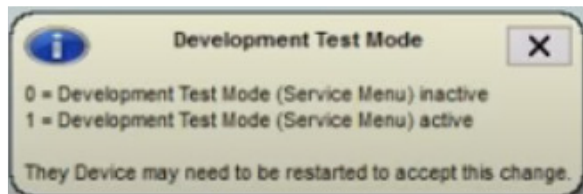
Then Adaption and change Channel 05 to 1 (was 0)

I've seen reported that on some vehicles it is Channel 06, and on some both Channel 05 and 06.

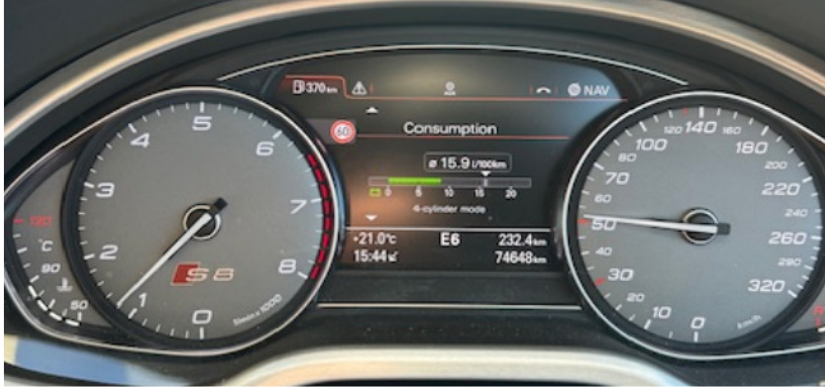
That is all I did so then I went for a drive, and it registered the first speed sign it saw;

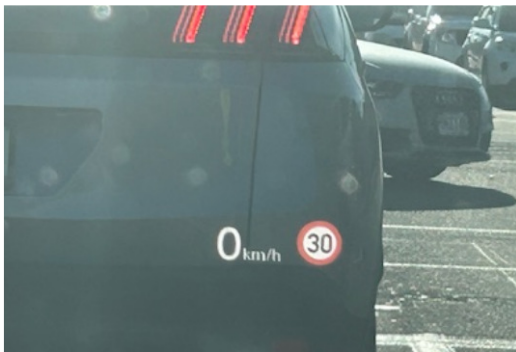
And on the Heads-Up display also – this time it picked up a temporary speed zone sign. I was stopped at lights here.

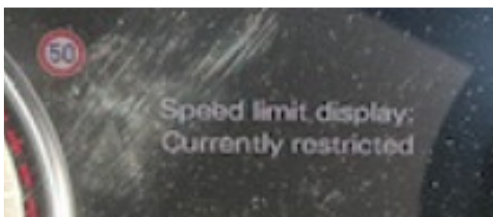
I do note that it does come up with an error from time to time;

Which may be due to the lack of navigation information, or may be that the sun was shining directly on the camera (late afternoon) or could also be that earlier in the drive we drove for 4 minutes before finding our first speed sign.

My car manual states that this error message is when the speed is only provided by one source -eg the camera (and not the Navigation system data – which is not present in New Zealand). I am Ok with the error just being present in the top line of the display – it isn't in the way.
